## **Kona Village Apartments Fire Bremerton, WA**

# **Kona Village Apartments Fire Bremerton, WA**

**November 13, 1997**

This is Report 121 of the Major Fires Investigation Project conducted by Varley-Campbell and Associates, Inc./TriData Corporation under contract EME-97-CO-0506 to the United States Fire Administration, Federal Emergency Management Agency.

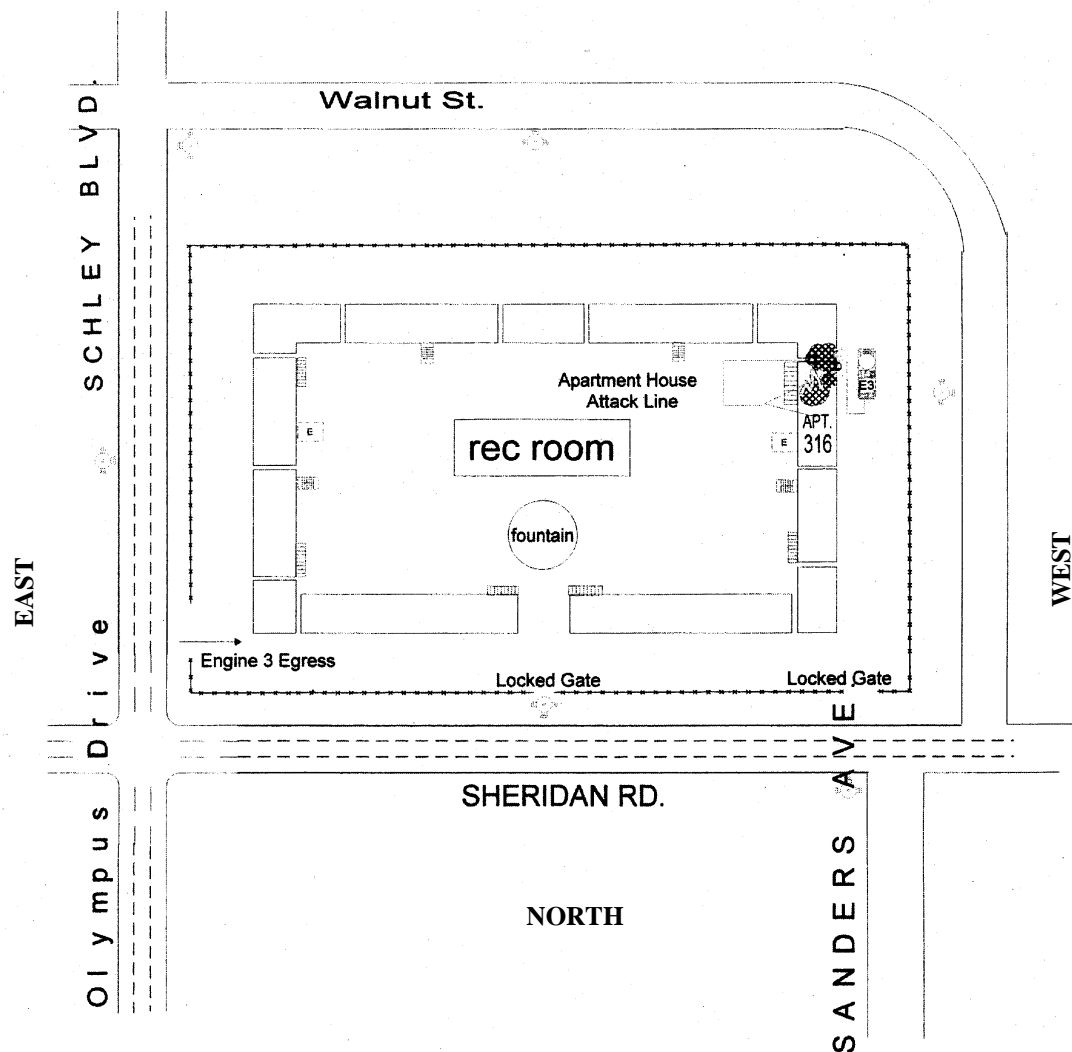
Diagram 2. Fire origin and first-in engine location

Diagram 2 indicates origin of fire and position of first arriving engine. Heavy smoke was evident of the west side and coming from the courtyard.

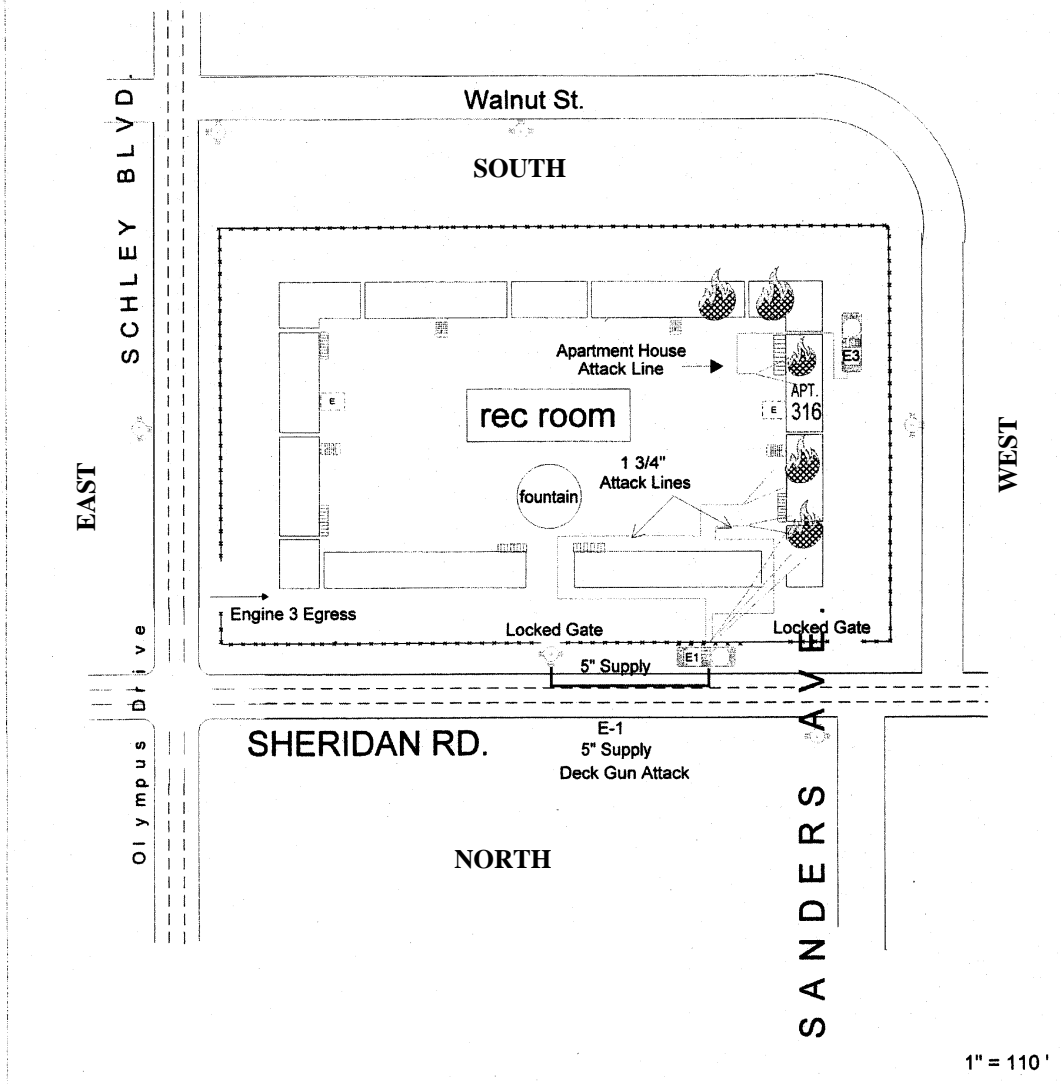
Diagram 3. Position of second engine and early fire travel

Diagram 3 indicates the position of second arriving engine (E-1) and extent of rapid fire travel. Conditions deteriorated from heavy smoke to heavy fire in a matter of seconds. E-1 hooked directly

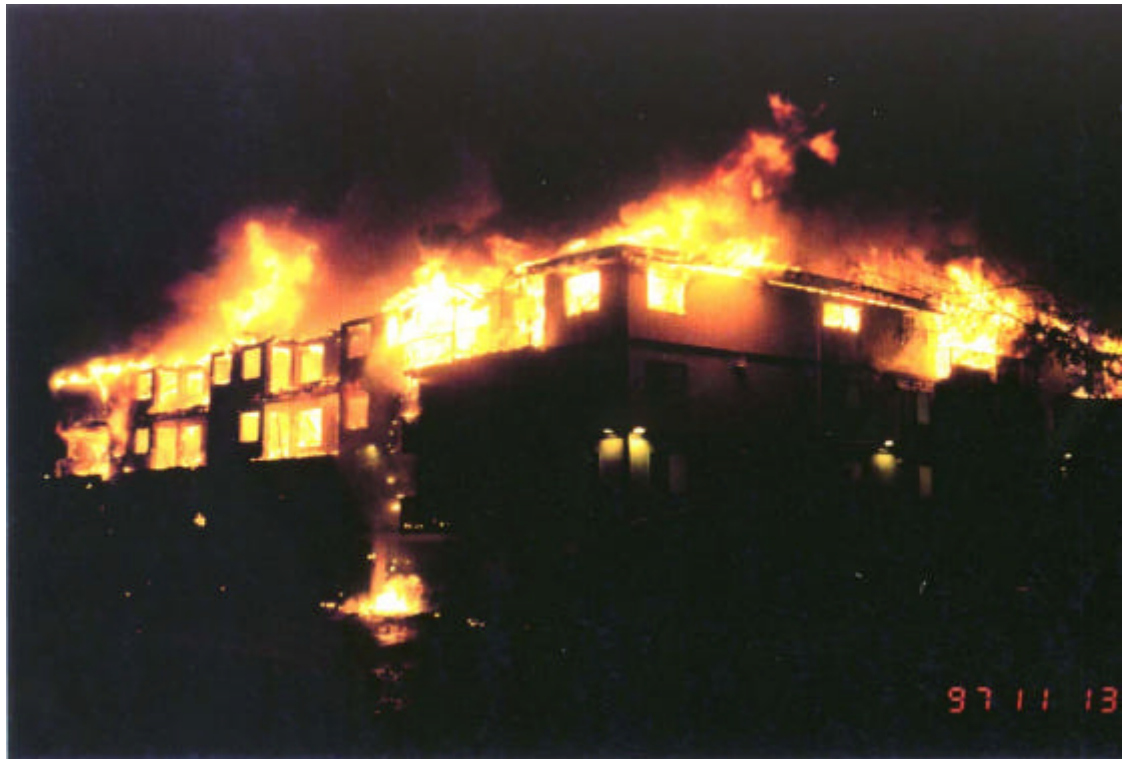
Photo 1 was taken at the southeast corner of building, shows fire conditions twenty minutes after dispatch.

The area of origin and location of the fatalities is at the left in the photo. The fire has extended horizontally through the attic area and dropped down via pipe chases and utility shafts.

*Photo 1. Extreme fire conditions at the southeast corner*

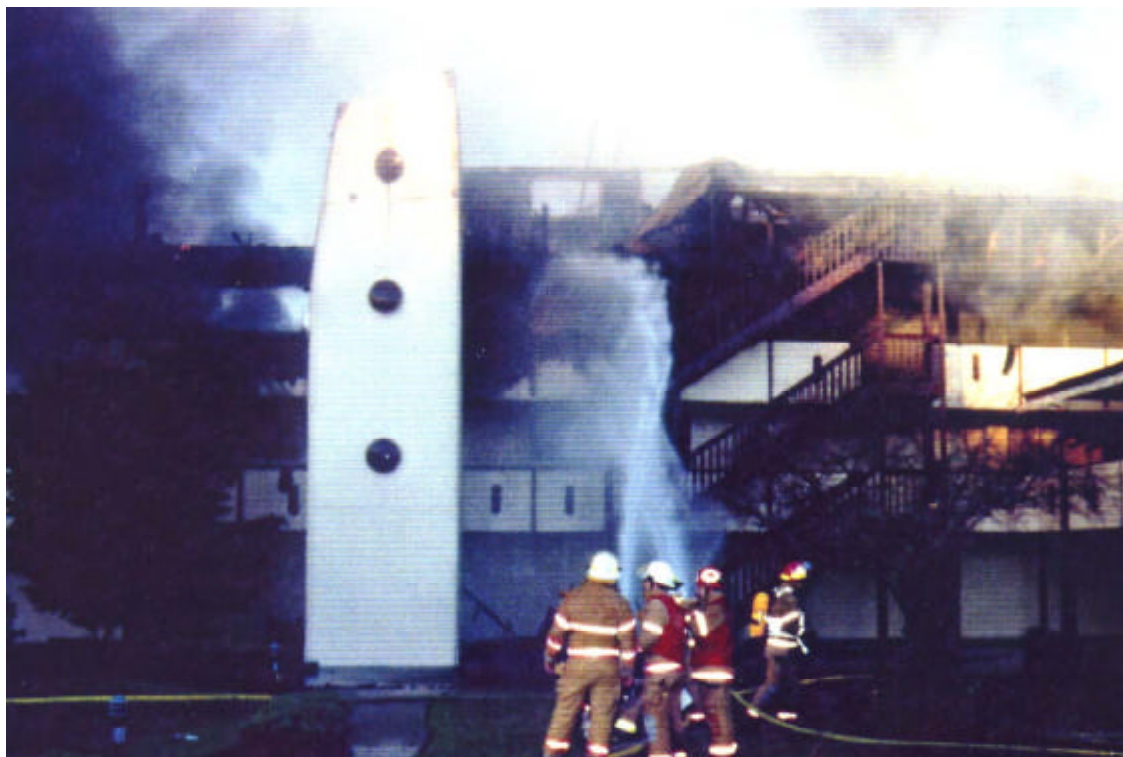
Photo 2 shows interior courtyard operations. Crews are deploying a portable monitor and multiple handlines to cutoff exterior fire extension. The two-story portion (north) is visible at the right. The enclosure to the left is the elevator. The apartment of origin is to the upper left.

*Photo 2. Interior operations in courtyard, west wing*

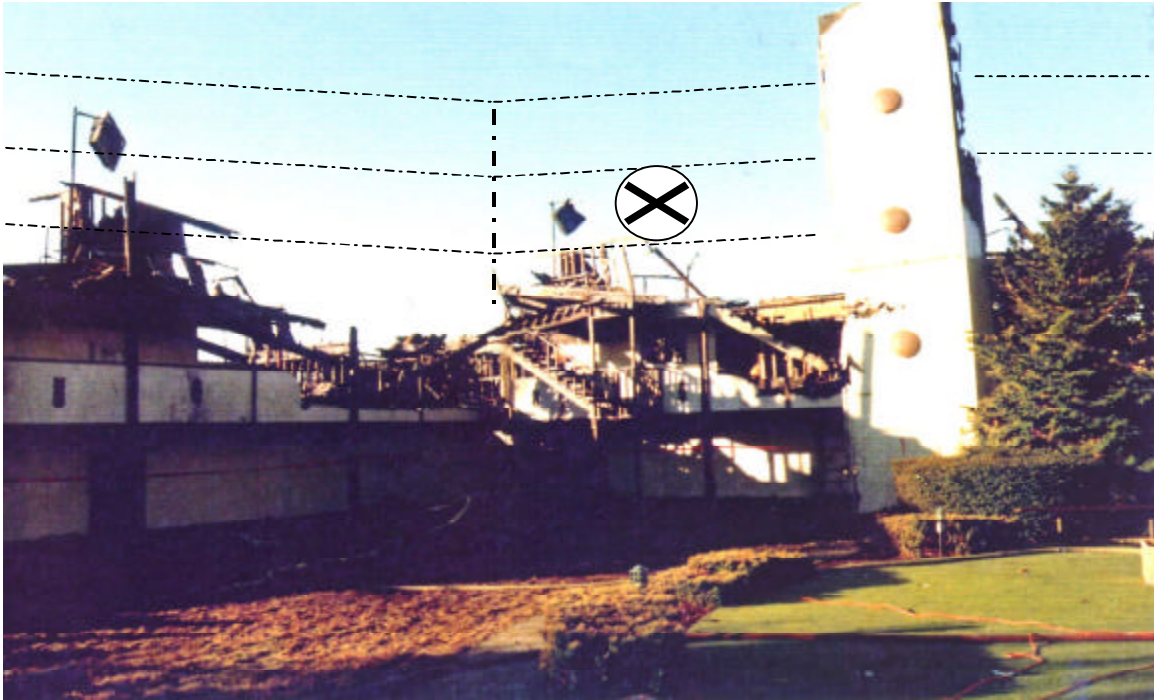
*Photo 3. The view from the interior courtyard toward the SW corner.  
The X approximates the apartment of origin. Note the hose cabinets and piping still standing*

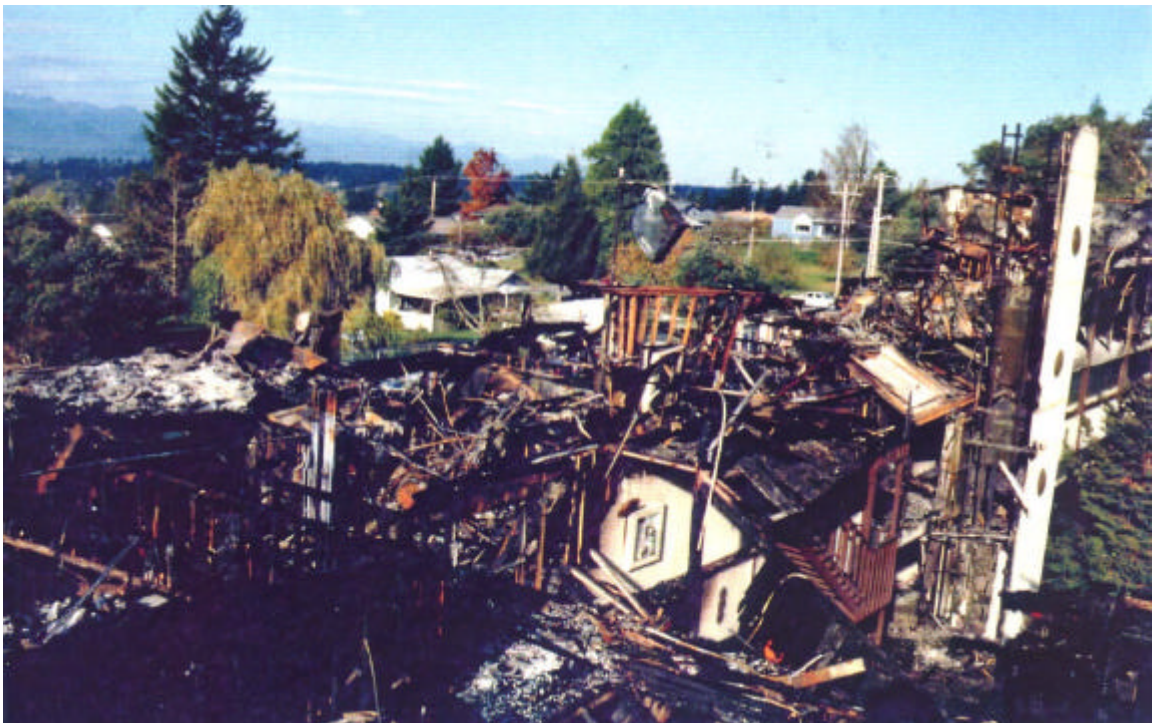
*Photo 4. An elevated view of the west wing looking in a NW direction.  
The apartment of origin is at the center left*

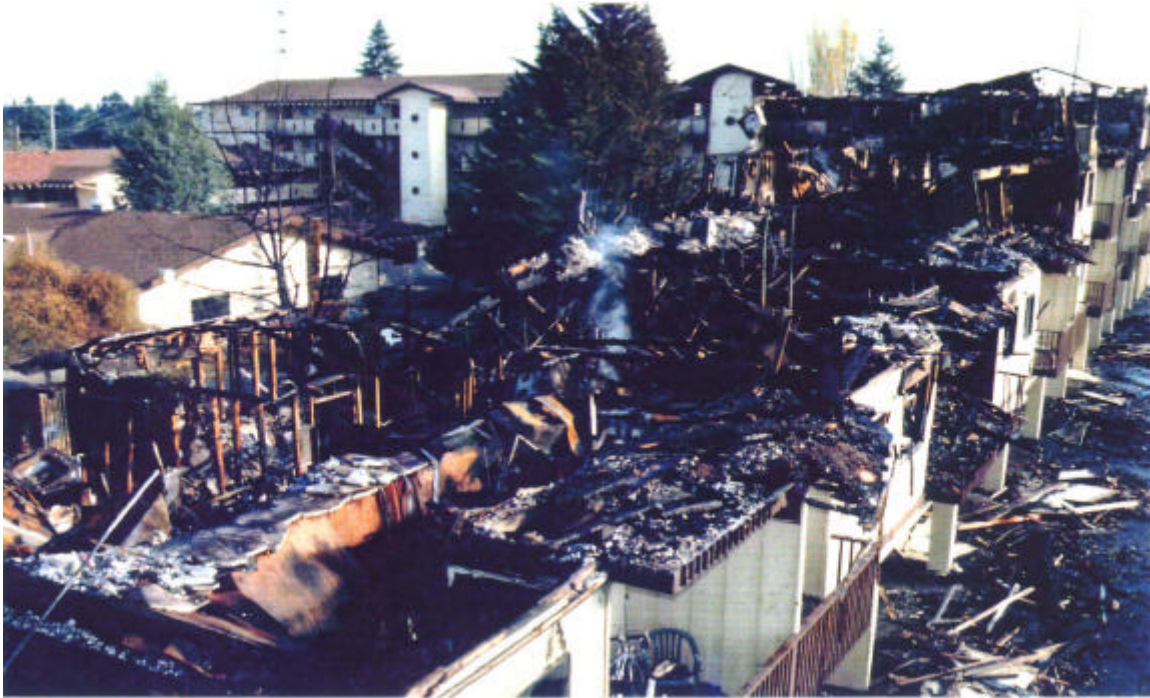
*Photo 5. An elevated view of the south wing toward the east wing.  
The fire was stopped at the SE corner*

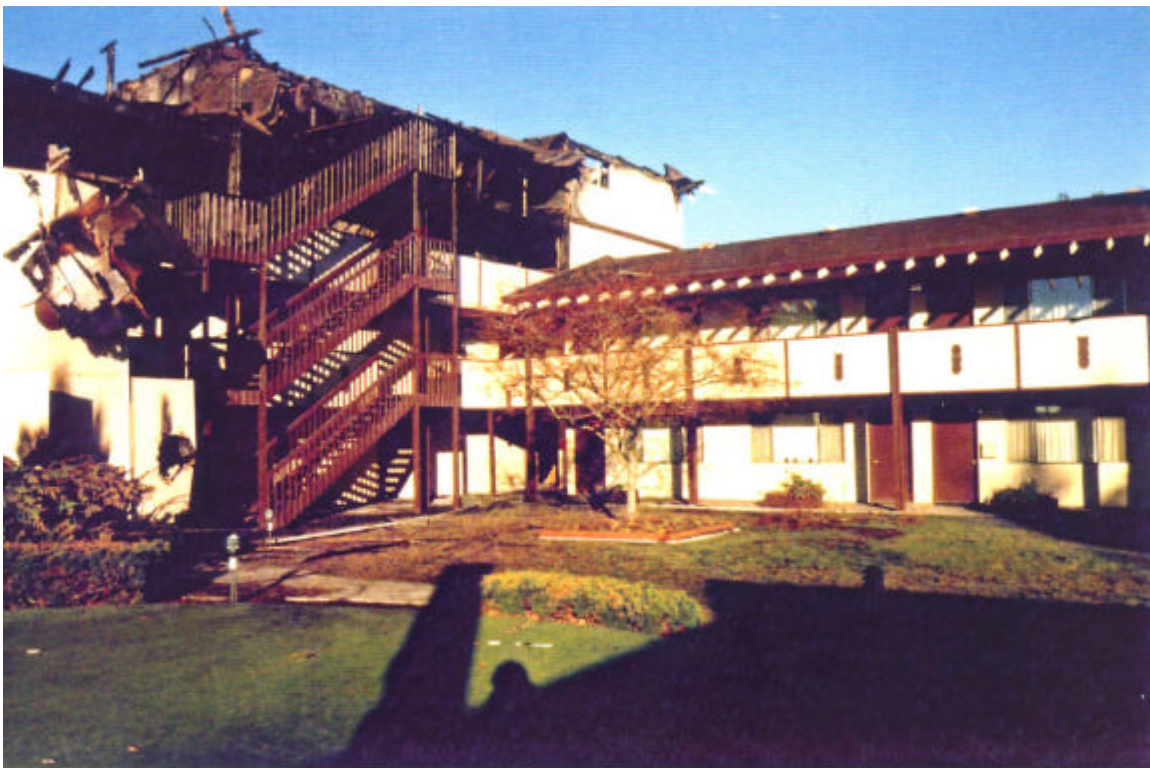
*Photo 6. The view from the interior courtyard looking toward the NW corner*
